NRL/MR/7120--04-8845

Acoustic Event Signatures for Damage Control: Water Events and Shipboard Ambient Noise

December 10, 2004

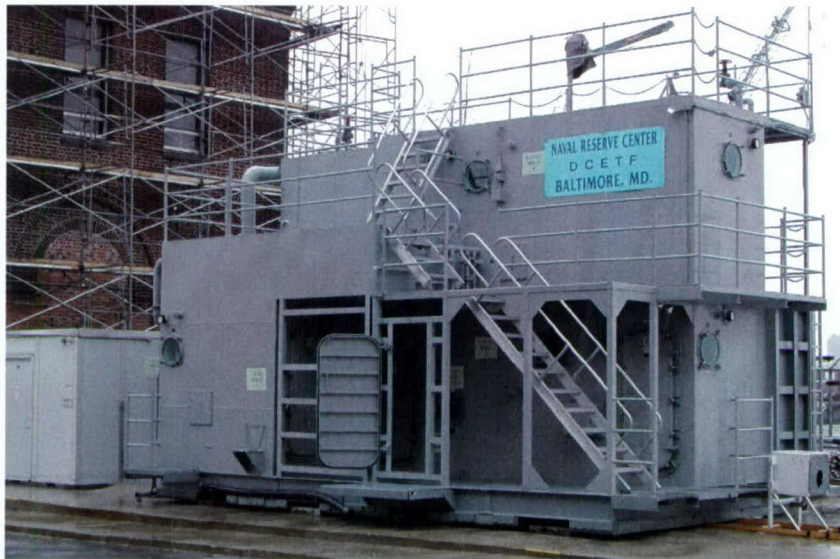
Fig. 1 – NAVSEA Damage Control Engineering Test Facility at the Ft. McHenry Naval Reserve Center, Baltimore MD. Tests were conducted in the various compartments inside the larger structure in the foreground. Recording took place inside the two sheds (one hidden) to the left rear.

The pipe rupture and flooding tests were conducted 14-15 May 2003 at the NAVSEA Damage Control Engineering Test Facility (DCETF) at the Ft. McHenry Naval Reserve Center in Baltimore, MD, shown in Fig. 1. Fifty-five events were run over two days. Each event typically lasted 2-3 minutes, except for the compartment flooding events, which took 5-6 minutes each.

As can be seen in Fig. 1 the building behind the DCETF was under construction. At the time of the tests workmen were chipping mortar from between the bricks preparatory to re-pointing the building. This was of some concern initially due to the noise generated by their work. However, the damage sounds proved to be much louder than the noise from their work inside the facility and have no effect on the results. While the ambient noise in the DCETF is of interest for this study, it should be noted for the record that it was a function of the level of activity of the workmen.

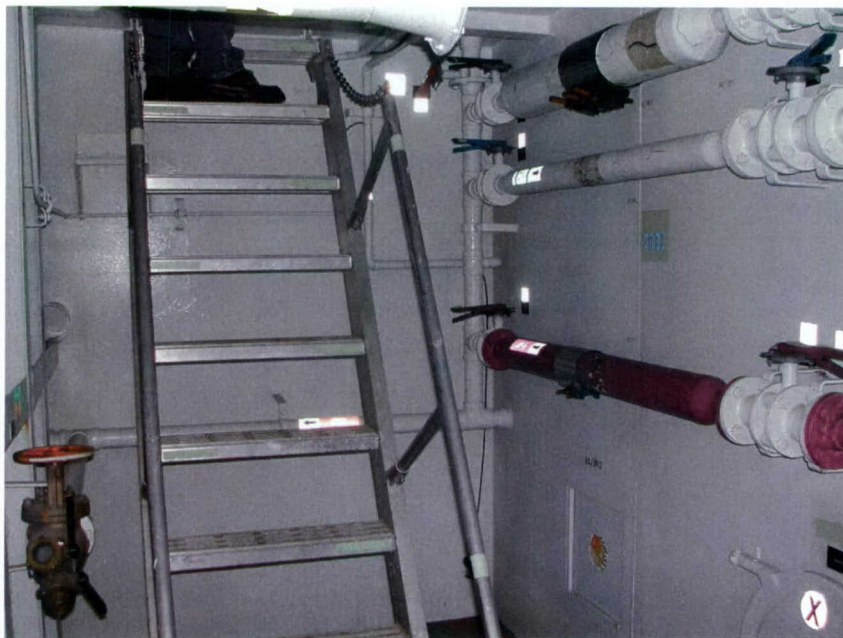
Fig. 2 – DCETF interior view of compartment A1 showing some of the “damages” and plumbing. The hatch to A2 is at the top of the ladder.

Figure 2 shows a view of the interior of a compartment and the "damages" and plumbing. A particular "damage" is selected by opening and closing the appropriate valves to cause water to flow through the damage. A large valve outside the compartment controls the water flow. The water supply, and pressure, is from the City of Baltimore's water system and is not necessarily the same pressure as might be found aboard a Naval ship. Two additional, related, observations are to be made about this setup. First, there is no actual sound of a pipe rupturing. Instead the pipe is already damaged and water simply flows out of it when present. Second, it was observed in most of the tests that one could hear the sound of water flowing in the pipes before it actually reached the rupture and began spraying into the compartment. This sound is probably not typical of a real rupture, as is the lack of an initial rupture sound, and has been ignored in our processing as far as is possible. A final observation is that there are no pipes near the deck. Thus, the objective of measuring damages at low, intermediate and high positions is to be interpreted as at mid-bulkhead, high-bulkhead and near-overhead heights. Further, only one event was run until the damage was submerged.
